# VICTORIAN CIVIL AND ADMINISTRATIVE TRIBUNAL

VCAT REFERENCE NO. BP993/2018

<b>APPLICANT</b>	Gavin Brown
<b>RESPONDENT</b>	S & B Weerasinghe Pty Ltd (ACN: 103 986 287) trading as SYD Homes
<b>WHERE HELD</b>	Melbourne
<b>BEFORE</b>	A T Kincaid, Member
<b>HEARING TYPE</b>	Hearing
<b>DATE OF HEARING</b>	20-21 March 2019, 29 April 2019
<b>DATE OF ORDER</b>	30 August 2019
<b>CITATION</b>	Brown v S & B Weerasinghe Pty Ltd (Building and Property) [2019] VCAT 1329

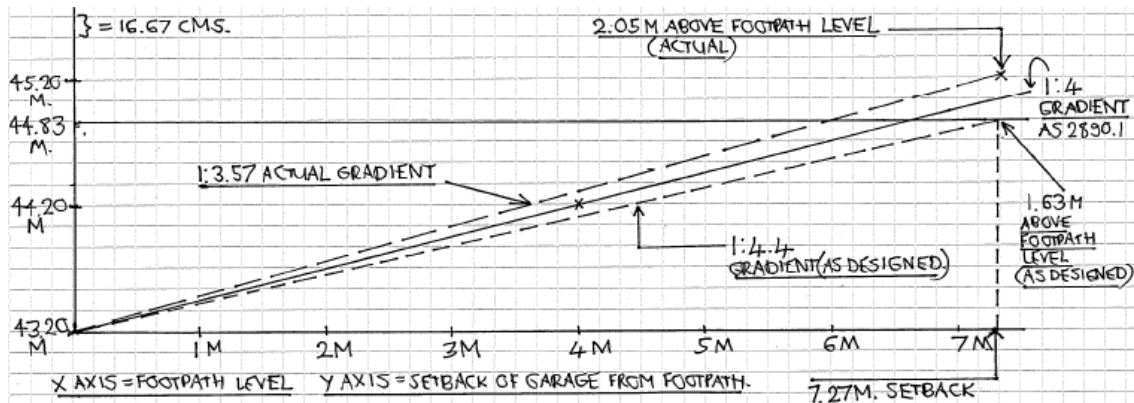
**Diagram A**

- 23 The designed gradient of 1:4.4, relative to the maximum gradient of 1:4 allowed by AS 2890.1 is shown in Diagram A below for illustrative purposes.

- 26 He concludes that this has resulted in a driveway gradient of 1:3.57, as also shown in Diagram A below.
- 27 S&B’s expert Mr Osborne’s calculations of the height of the garage above the footpath are broadly similar to Dr Barrowclough’s: Mr Osborne calculates that the height of the garage is approximately 1.95 metres above the level of the footpath. He arrived at this calculation by taking the height of one side of the driveway (where it meets the garage) of 2.043 metres,

Experts Agree that the construction of the driveway does not meet AS 2890.1

- 28 The respective experts engaged by the parties both conclude that the driveway exceeds the required guidelines of 1:4, and is therefore defective.
- 29 Further, Mr Osborne, called by the builder, has also concluded that there are ineffective “transition” zones.
- 30 I also find, in particular, that the gradient of the driveway does not meet the requirements of the contract, and is therefore defective work by S&B, rendering S&B in breach of the implied warranties to which I have referred.

- 52 Diagram A above assists in this respect. It demonstrates the small extent to which the actual gradient of the driveway of 1:3.57 was greater than the 1:4 maximum gradient required by the relevant Australian Standard.
- 53 I am of the view that the Australian Standard of a 1:4 gradient prescribes a maximum gradient that many in the community would regard as “steep”. The argument that Mr Brown should have appreciated that the driveway was marginally above this gradient, as shown in Diagram A, cannot be sustained.
- 54 I also do not accept that the test is whether the owner should have realised that the actual gradient is higher than a gradient of 1:1.5. This is the lesser gradient which Mr Osborne, the expert called by S&B, suggests is the gradient commonly recommended by Councils, such as will generally avoid the need for transition zones.
